ONLINE MONITORING OF CORROSION UNDER CATHODIC PROTECTION CONDITIONS UTILIZING COUPLED MULTIELECTRODE SENSORS

Xiaodong Sun
Corr Instruments, LLC
San Antonio TX, USA

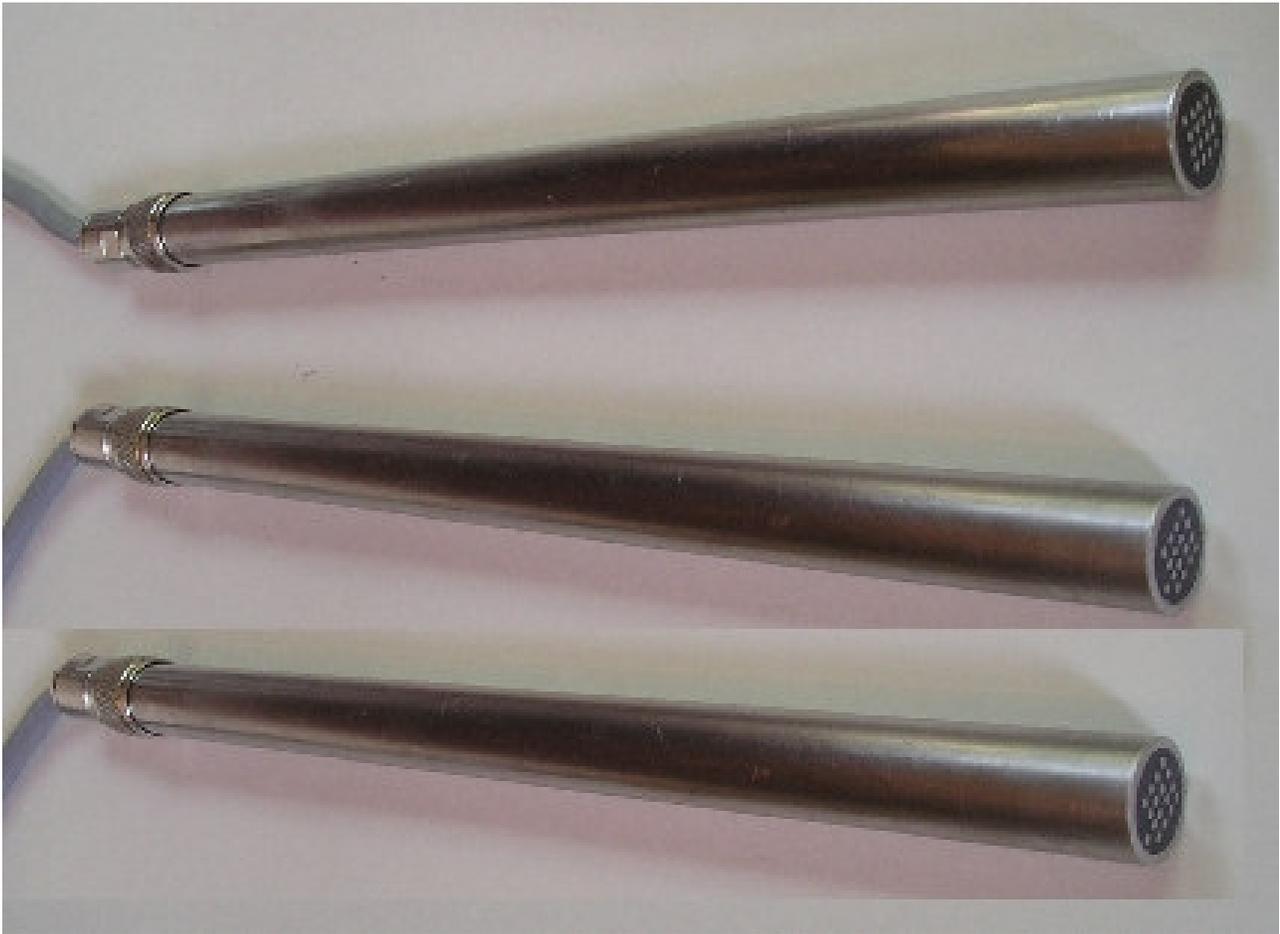
Figure 1. Typical coupled multielectrode sensors used in the experiment.

The sensing electrodes of the coupled multielectrode sensors were made from an annealed mild carbon steel wire (concrete rebar wire), 1.5 mm in diameter and 1.77 mm² in electrode surface area. Each sensor had 16 electrodes flush-mounted in epoxy. Typical sensors that were used in the experiment are shown in *Figure 1*. Prior to the test, surfaces of sensing electrodes for each multielectrode sensor were polished to 320 grit and rinsed with distilled water and acetone. The sensors were tested in distilled water, a simulated 3%wt of sea salt water (Vigo Importing Co., Tampa, Florida), and a solution of 3%wt sea salt plus 10 mM H₂O₂. The experiments were conducted at 27°C.

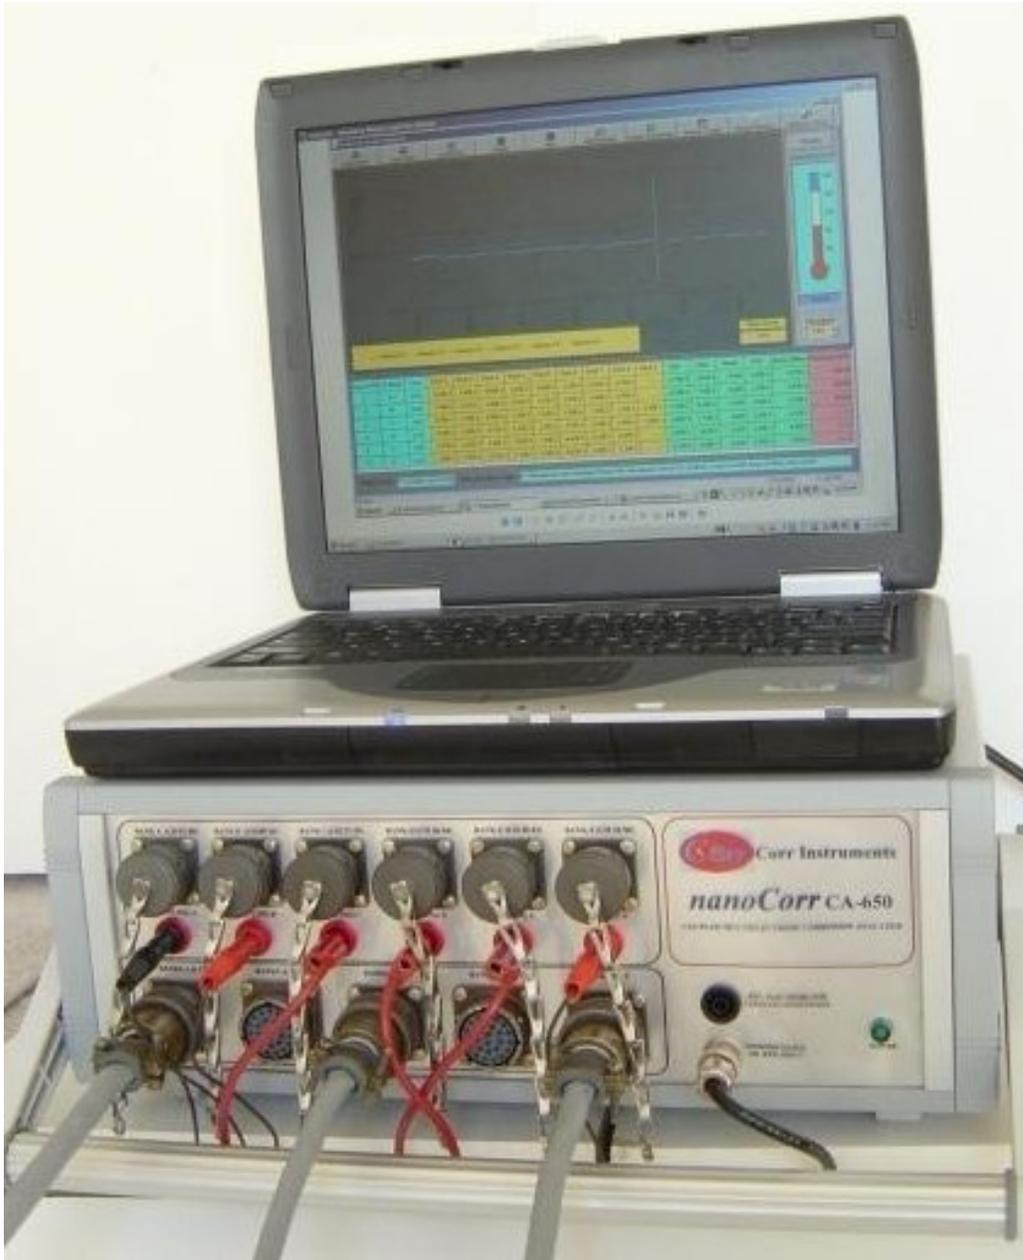
Figure 2. Coupled multielectrode corrosion analyzer system used in the experiment.

A nanoCorr^{TM*}-50 coupled multielectrode analyzer,^{5,6} manufactured by Corr Instruments (San Antonio, TX, USA), was used in the experiment. This coupled multielectrode analyzer has a high current resolution (10⁻¹² A) and allows the measurement of coupling currents up to 50 electrodes in up to six separate sensors at the same time. *Figure 2* shows that three sensors were connected to the coupled multielectrode analyzer and measured at same time. The common coupling joint of each sensor was connected to a carbon steel coil made of the same wire as the sensing electrodes and immersed in the same solution, to stabilize the potential during the normal measurements. The coupling joint of the sensor was connected to a power supply during the measurements, under cathodic or anodic polarization conditions. A stainless steel tube was used as the counter electrode for the polarization of the sensing electrodes. The potential of the common joint of each sensor (the electrochemical potential of the sensor electrodes) was measured by the multielectrode analyzer, against a saturated calomel reference electrode (SCE). A notebook computer and the factory-supplied software, CorrVisual^{TM*}, were used in conjunction with the multielectrode analyzer. The currents from each electrode, the electrochemical potential of each sensor, and the temperature were logged at a user-specified interval (usually 20 to 120 seconds) and saved in a computer file. Processed signals, such as the localized corrosion current, the cumulative charge for each sensor, and the corrosion rate and cumulative corrosion damage (or penetration depth) for each sensor were also saved in one or more separate data files at user's choice. During the measurements, all the directly measured currents and the processed results (such as the minimum current, maximum current, mean current, current densities, corrosion rates, cumulative charges, penetration depth, and electrochemical potential), as well as the set-up parameters for data acquisition, were also dynamically available from the computer screen in both numerical and graphical forms.

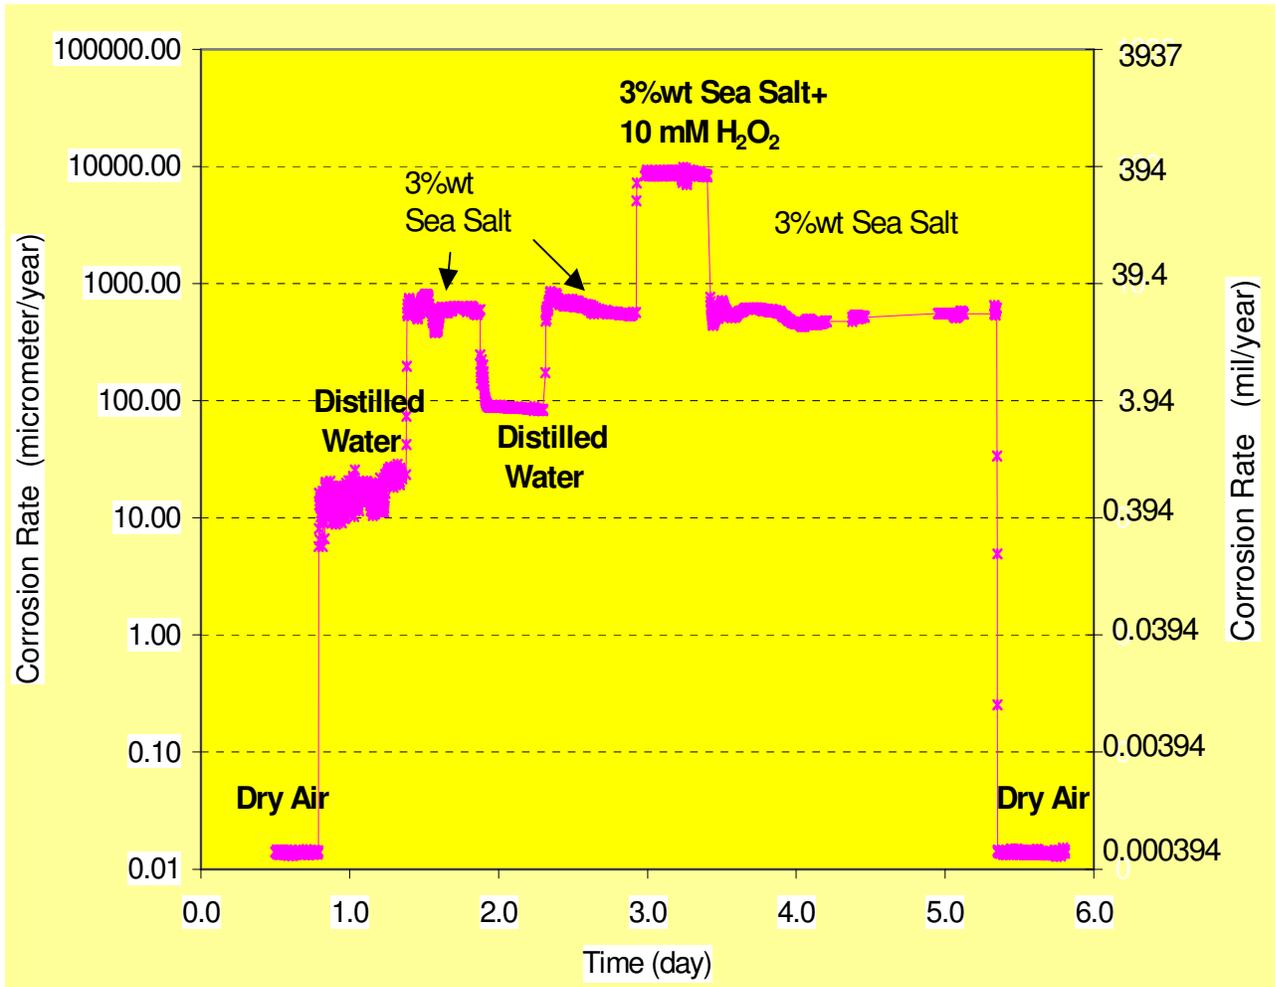
Figure 3. Typical responses of carbon steel sensors to the changes of solution chemistry. The signals measured in dry air (~14 nm/year) are close to the lower detection limit of the sensor system (1.4 nm/year).

To verify the performance of the multielectrode analyzer system, it was tested with carbon steel sensors in different solutions. *Figure 3* shows a typical response curve obtained from the different solutions. The sensor signal (corrosion rate) was about 1.4×10^{-2} micrometer/year (14 nanometer/year, or 0.00055 mil/year) in air, which is close to the lower detection limit of the sensor measurement system (1.4 nanometer/year). Upon the immersion of the sensor in distilled water, the signal increased instantaneously by 3 orders of magnitude, indicating a slight corrosion for carbon steel in distilled water (10 micrometer/year or 0.39 mil/year). As corrosion that took place on the sensor may alter the local chemistry, such as pH near the corroded electrodes, the corrosion signal gradually increased in the distilled water. Over a period of 12 hours, the corrosion rate increased, from 10 micrometer/year (0.39 mil/year) to 20 micrometer/year (0.78 mil/year). When the sensor was immersed in the simulated seawater (3%wt salt solution), the signal increased to 800 micrometer/year (31.5 mil/year) and stabilized at this value. When the sensor was immersed in the distilled water again, the corrosion rate decreased and stabilized at a value that is slightly higher than the previous value measured in the same water, suggesting that the previous value was not stabilized. Another reason for the slightly higher value in the second immersion in the same distilled water was that the sensing electrode had been corroded before the second immersion. The corrosion products, or the residue sea salt that was trapped on the sensor surface and not completely removed during the rinsing prior to the second immersion, may also have caused the increase of the corrosion rate. When the sensor was returned to the simulated seawater, the corrosion rate returned to the value measured previously in the same solution.

Upon the addition of H_2O_2 to the 3% sea salt solution (10 mM H_2O_2 concentration), the corrosion rate increased significantly and stabilized at about 10 mm/year (394 mil/year) in a few data sampling cycles (the sampling interval was set to 2 minutes). The sensor reproduced the previous signals when it was re-immersed in the same simulated seawater or placed in air. The response curve also showed good reproducibility and stability of the sensor, whether after decreasing from a higher value or after increasing from a lower value in the simulated seawater, over the testing period. The signal measured in air showed that the sensor is extremely sensitive and capable of measuring corrosion rate near the designed lower detection limit—1.4 nanometer per year.

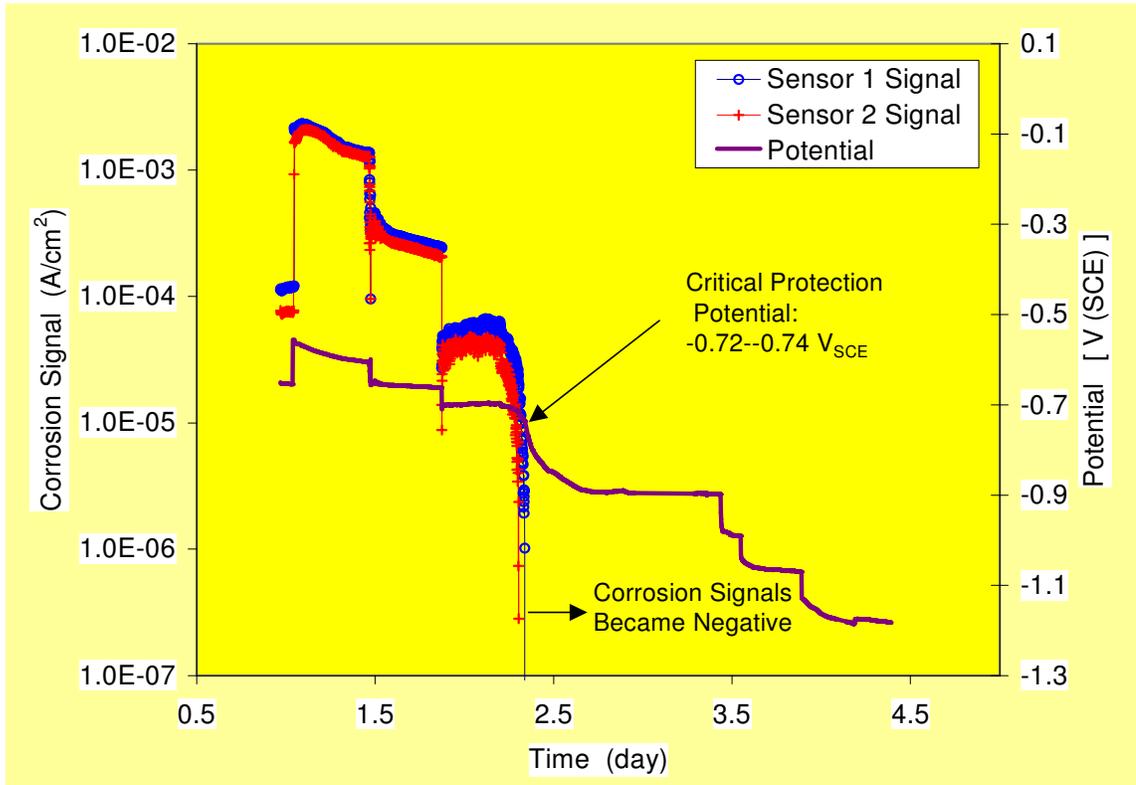
Figure 4. Responses of the corrosion signals (anodic current densities) of the sensors to the changes of the cathodic protection potential in a 3% wt sea salt solution. For detailed signal changes near and below the critical protection potential, see Figure 5.

Typical responses of the carbon steel sensor signals to the CP potential are shown in *Figure 4*. The signal for each sensor was automatically calculated by the factory-supplied software during the measurement, based on the current from the most corroding or the most active electrode among all the sensing electrodes.² (The signals based on the mean plus 2.5 or 3 times the standard deviation of the currents are also available from the software.) At the start of the test, the potential was controlled near the free open circuit potential, by connecting the common joints of the sensors to a separate large carbon steel coil that was made from the same wire as the sensing electrodes. The signal was 8×10^{-5} to 1.2×10^{-4} A/cm² (corresponding to approximately 1 mm/year) at the free open circuit potential, which is consistent with the result measured in the same solution as shown in *Figure 3*. The corrosion signals increased to approximately 2×10^{-3} A/cm² (corresponding to approximately 30 mm/year), when the potential was increased by approximately 0.08V. The corrosion rate gradually decreased with the decrease of potential,

sharply dropped when the potential was near, and became negative when the potential was below the critical protection potential. In this paper, the critical protection potential is defined as the highest potential at which all the carbon steel electrodes were fully protected.

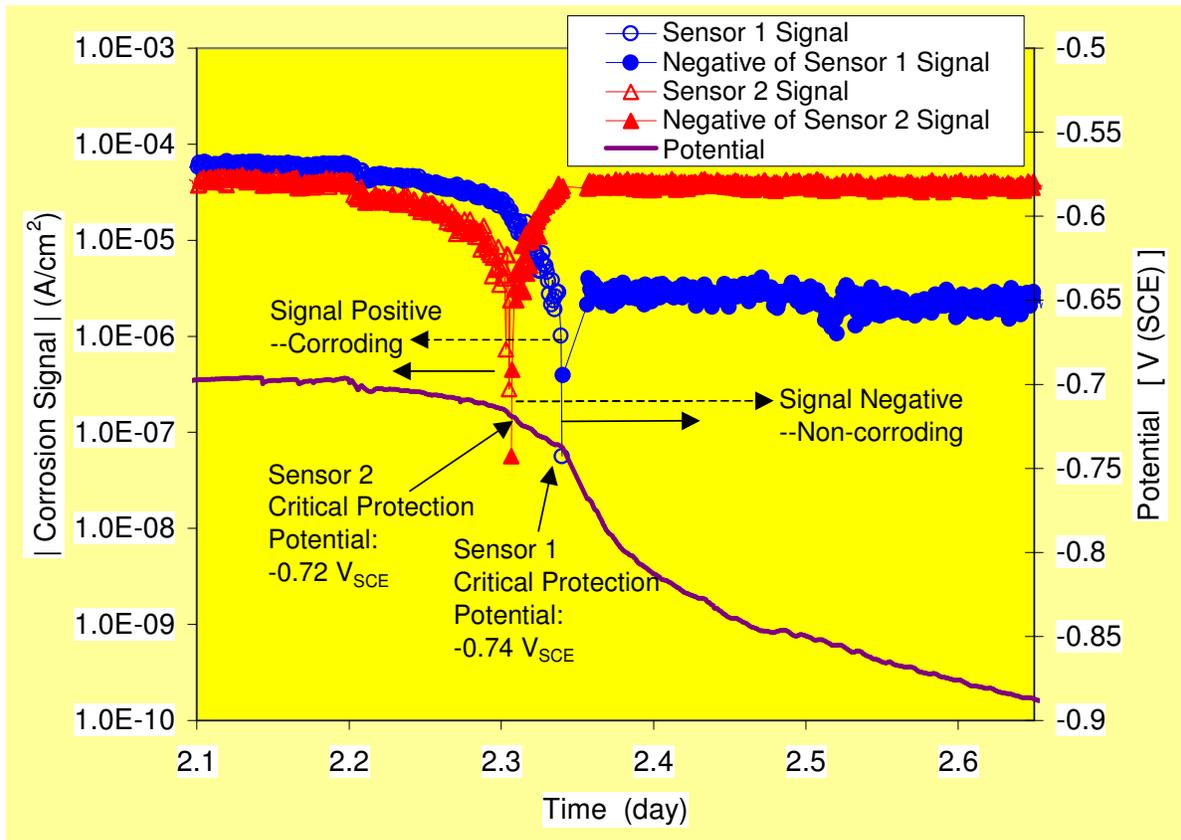
Figure 5. Responses of the absolute values of the sensor corrosion signals to the changes of the cathodic protection potential near and below the critical protection potential in the 3% wt sea salt solution. The sensor corrosion signals became negative upon reaching the critical protection potential, indicating there was no corrosion on the sensing electrodes when the potential was below the critical protection potential.

Figure 5 pictures the enlargement of the responses of the absolute values of the sensor corrosion signals near and below the critical protection potential. The corrosion signals stabilized at -4×10^{-5} A/cm² for sensor #2, at -3×10^{-6} A/cm² for sensor #1, and were relatively independent of the potential, when the cathodic protection potential was changed between the value slightly below the critical protection potential and -1.18 V_{SCE}. In *Figure 5*, the corrosion signal was the current density measured from the most corroding or most active electrode among all the sensing electrodes in the sensor. The negative corrosion signal suggests that the most active electrode in the sensor was actually a cathode (equivalent to the most active site in a metal piece being a cathodic site) and effectively protected, when the potential was below the critical protection potential. This implies that all the electrodes in the sensor (equivalent to all areas of the metal piece) were effectively protected by the cathodic protection, when the potential was below the critical protection potential.

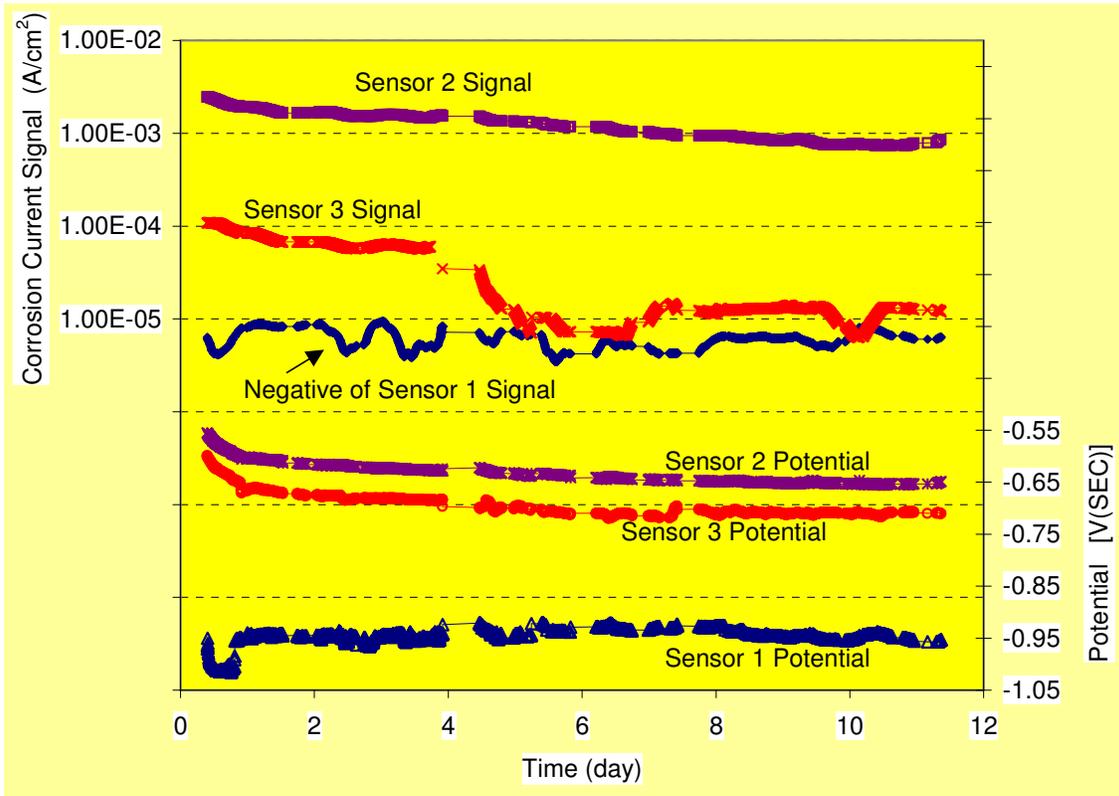
Figure 6. Corrosion current signals and the potentials of the sensors during the monitoring period. The corrosion signal from sensor #1 was negative (-6×10^{-6} to -1×10^{-5} A/cm²), indicating no corrosion was taking place on sensor #1 electrodes.

Three sensors (sensors #1, #2, and #3) were used in the measurements. Sensor #1 was cathodically polarized to approximately -0.9 V_{SEC}, which is well below the protection critical potential. Sensor #2 was slightly anodically polarized, to simulate a faulty polarity connection in the CP system. Sensor #3 was left at the free corrosion potential, to simulate an inefficient protection from the CP system or the unprotected condition. *Figure 6* shows the measured corrosion current density signals and the potentials of the three sensors during the monitoring period. In *Figure 6*, the corrosion current density signal for each sensor was automatically calculated by the software based on the mean value plus 2.5 times the standard deviation of the currents² during the measurement. The corrosion current from sensor #1 was negative throughout the monitoring period, indicating that there was no corrosion on the sensing electrodes of sensor #1. The corrosion current of sensor #3 was approximately 10^{-4} A/cm² during the first 4 days of monitoring and decreased to approximately 10^{-5} A/cm² on the 5th day. The corrosion current signal from sensor #2 was approximately 10^{-3} A/cm² throughout the monitoring period, indicating that the corrosion increased by more than one order of magnitude, when the potential was raised by approximately 0.07 V from the free corrosion potential. The slight decrease of the free corrosion potential of sensor #2 over the monitoring period was probably due to the pH increase caused by the relatively large cathodic reaction of oxygen on the stainless steel counter electrode used to anodically polarize sensor #2. At the end of the test, a large amount of rust deposit was observed at the electrochemical cell, suggesting a high pH solution.

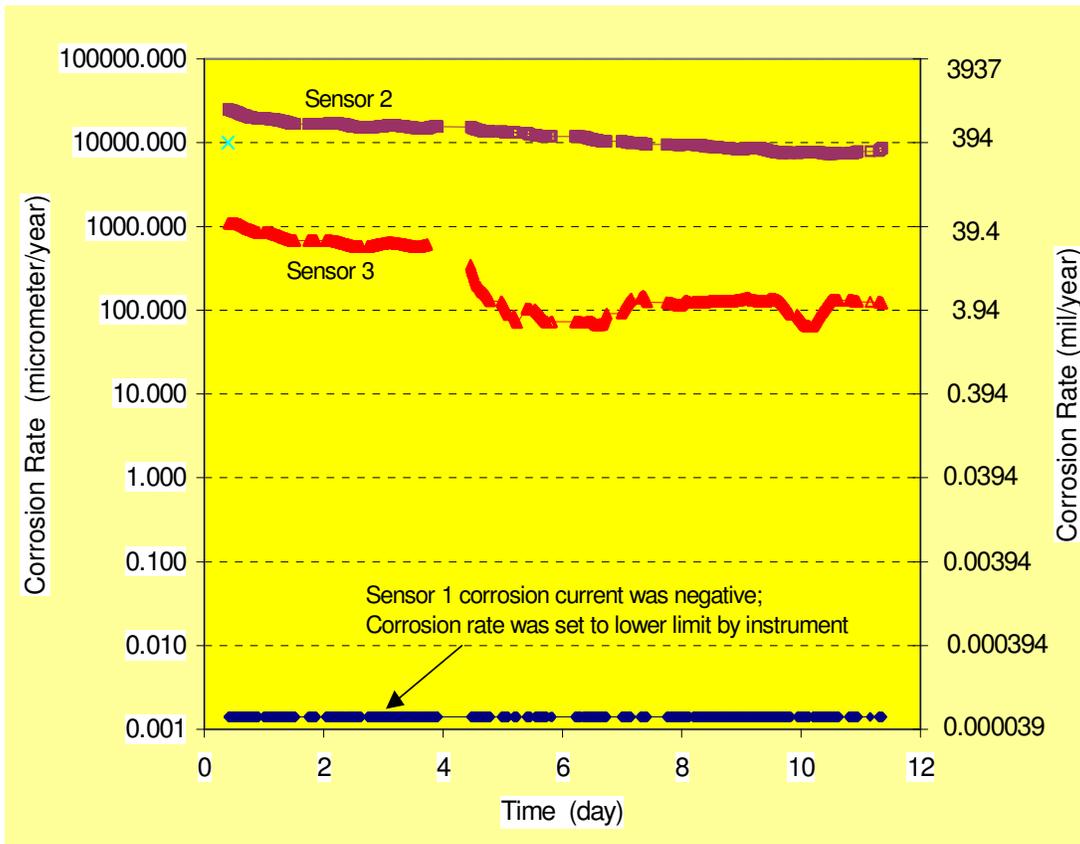
Figure 7. Measured corrosion rate during the monitoring period. Sensor 1 corrosion rate was set to the lower detection limit (1.4 nm/year) by the instrument, because its current was negative, indicating there was no corrosion on the sensing electrodes.

The corrosion rates for the three sensors were also available from the software during the measurement (*Figure 7*). The corrosion rate of the unprotected sensor—sensor #2—in the first 4 days was approximately the same as the value measured in the previous measurements, which were conducted with similar sensors in the simulated seawater (*Figure 2*). However, the rate was slightly lower after the 5th day. The difference between the values measured in the first 4 days and the values measured after the 5th day (*Figure 7*) is within the expected range of variations for localized corrosions in a given environment. The corrosion rate for sensor #1 was automatically set to the lower detection limit of the instrument because its corrosion current signal was negative, indicating that there was no corrosion.

significant pitting corrosion was observed on the electrodes of sensor #1. The result, as shown in *Figure 8*, is in agreement with the measured corrosion rate shown in *Figure 7*. In addition, *Figure 7* shows that the average corrosion rate for sensor #2 was 12.7 mm/year. Hence, the total penetration depth for the most corroded electrode on sensor #2 should be 0.38 mm, after the 11 days of exposure. The measured depth of the most corroded electrode on sensor #2, as shown in *Figure 8*, was approximately 0.4 mm, which is in excellent agreement with the depth estimated by the coupled multielectrode sensor.

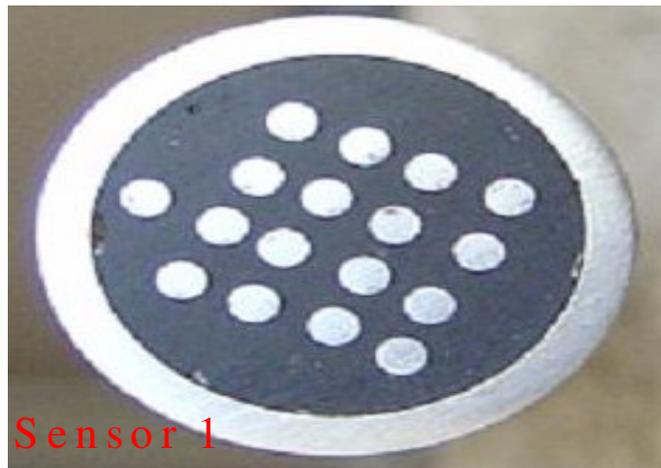
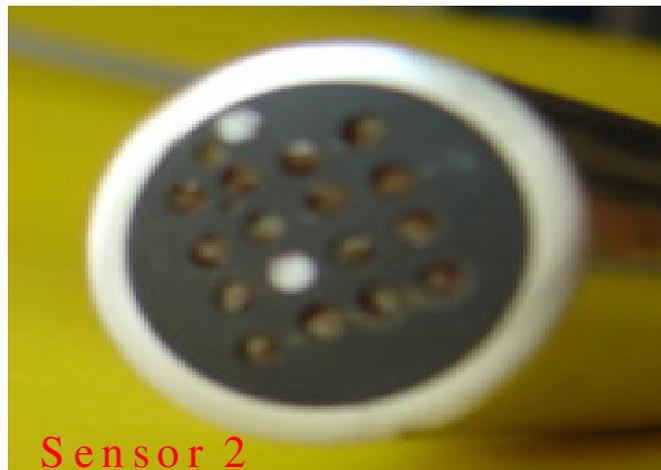
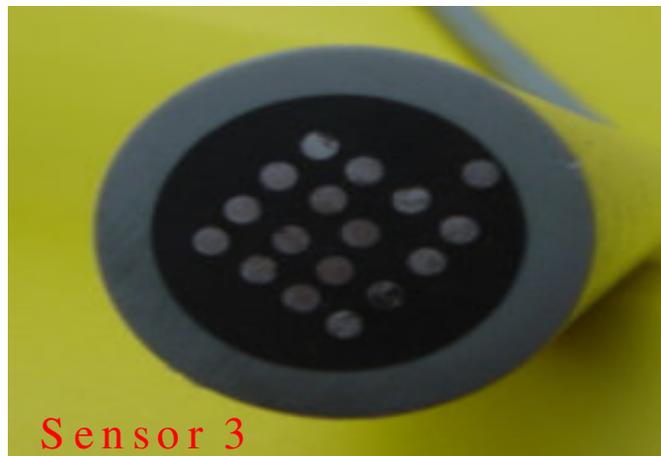
Figure 8. Appearances of the electrodes of sensors after the monitoring period. Sensor #1 electrodes were cathodically protected. Sensor #2 electrodes were anodically polarized except the shiny one that had a faulty connection (at row 3 and column 2). Sensor #3 electrodes were maintained near the free corrosion potential. The electrode outside the 4 by 4 matrix in each sensor was used as a position locator and was not part of the sensing electrodes.

Figure 8 shows the appearance of the sensor electrodes after the monitoring period. Clearly, all the electrodes of sensor #2 (except the one with faulty connection at the location of row 3 and column 2) were severely corroded. Slight pitting corrosion can be noticed on some of the electrodes of sensor #3. No
