LOCALIZED AND GENERAL CORROSION OF COPPER IN AZOLES AND SILICA INHIBITED ZERO BLOWDOWN COOLING WATER IN AN AUTOMOTIVE PLANT

Dan Duke
Water Conservation Technology International, Inc.
Temecula, CA

Lietai Yang
Corr Instruments, LLC
San Antonio, TX

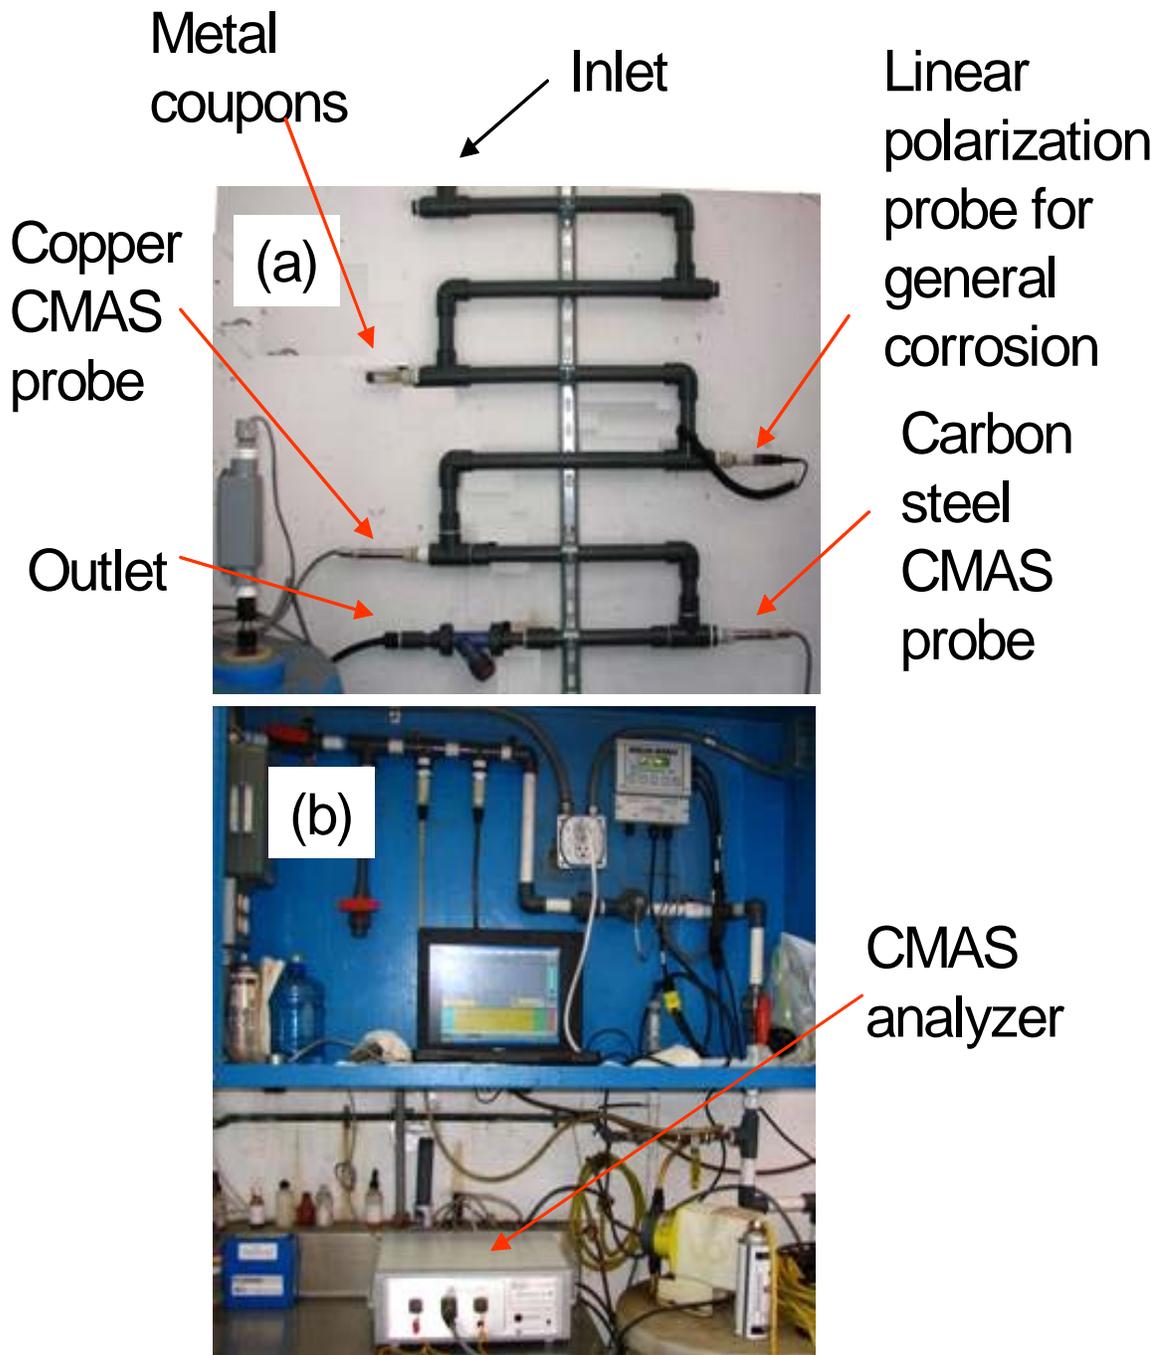
Figure 1. The installation of the CMAS and LPR probes in the sampling station and the instruments used in the tests

An 18-channel (Model A-18*) nanoCorr™* CMAS analyzer was used to gather the real time data from the CMAS probe. The CMAS analyzer was interfaced with a notebook computer which has the CMAS analysis software, CorrVisual™*. The computer displayed the data from the CMAS analyzer and save them into its memory. Figure 1(a) shows the installation of the copper and a carbon steel CMAS probes in the sampling station of the cooling water system. Because the particular model of the CMAS analyzer available had only 18 channels and can be used only for one 16-electrode probe at a given time, the CMAS analyzer was connected to and only monitored the copper probe during the test due to the priority of affirming copper corrosion control. Figure 1(b) shows the computer and the CMAS analyzer used during the experiment.

Linear polarization resistance (LPR) method is a widely used method in the cooling water industry for general corrosion monitoring.⁴ The LPR copper probe was installed in the same station as shown in Figure 1(a). A handheld LPR corrosion rate meter (Aqua Mate[†], P/N 710700) was connected periodically to the LPR copper probe to take the general corrosion rate readings.

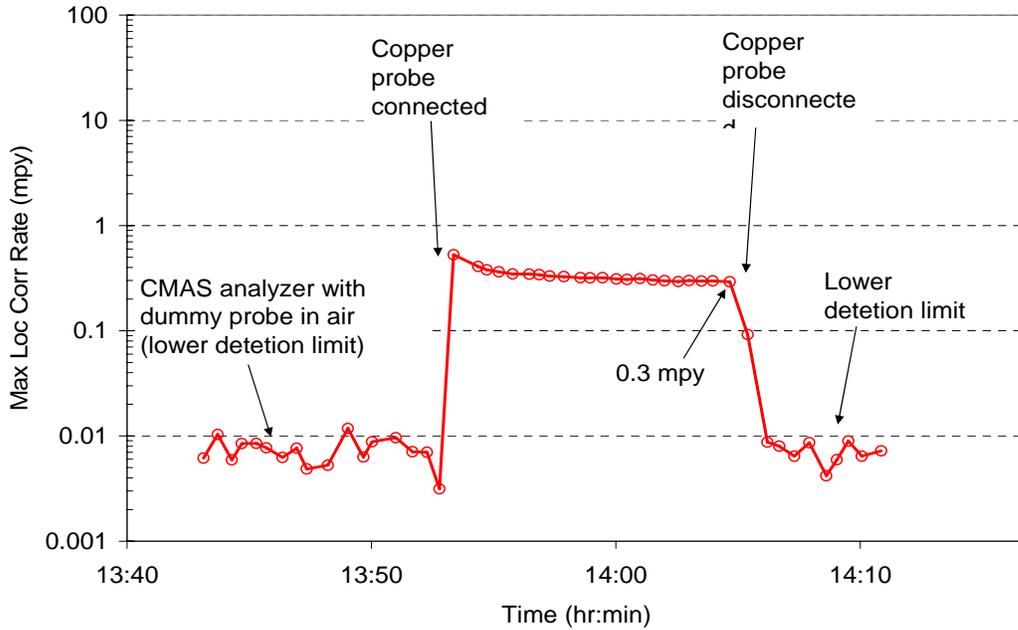
Figure 2. Short-term localized corrosion rate measured with the copper CMAS probe before the change from traditional chemical treatment. Note: to convert the corrosion rate from mpy to mm/yr, multiply by 0.025.

Because of the unavailability of the CMAS analyzer at the start of the project, only short-term localized corrosion rate was obtained from the copper probe. Figure 2 shows the short-term maximum localized corrosion rate from the copper CMAS probe. The maximum localized corrosion rate was the rate calculated from the current measured on the electrode that was experiencing the highest corrosion rate. This electrode is called the most corroding electrode and it simulates the behavior of the fastest

growing pit in a pitting corrosion case. The stabilized maximum localized corrosion rate was approximately 0.3 mpy (7.6 $\mu\text{m}/\text{yr}$) for copper.

When the CMAS analyzer was not connected to a probe, its multiple-pin connectors at the end of the cable was in air. If the air is humid, these pins would corrode in air and gives the corrosion rate of the connector pins in air. If the environment is noisy, the noise signal may also be picked up by the analyzer. Therefore, the connector is equivalent to a dummy probe and the signal from the dummy probe represents the lower detection limit of the CMAS analyzer in the environments. Figure 2 shows that the lower detection limit is 0.01 mpy (0.25 $\mu\text{m}/\text{yr}$) under the test conditions.

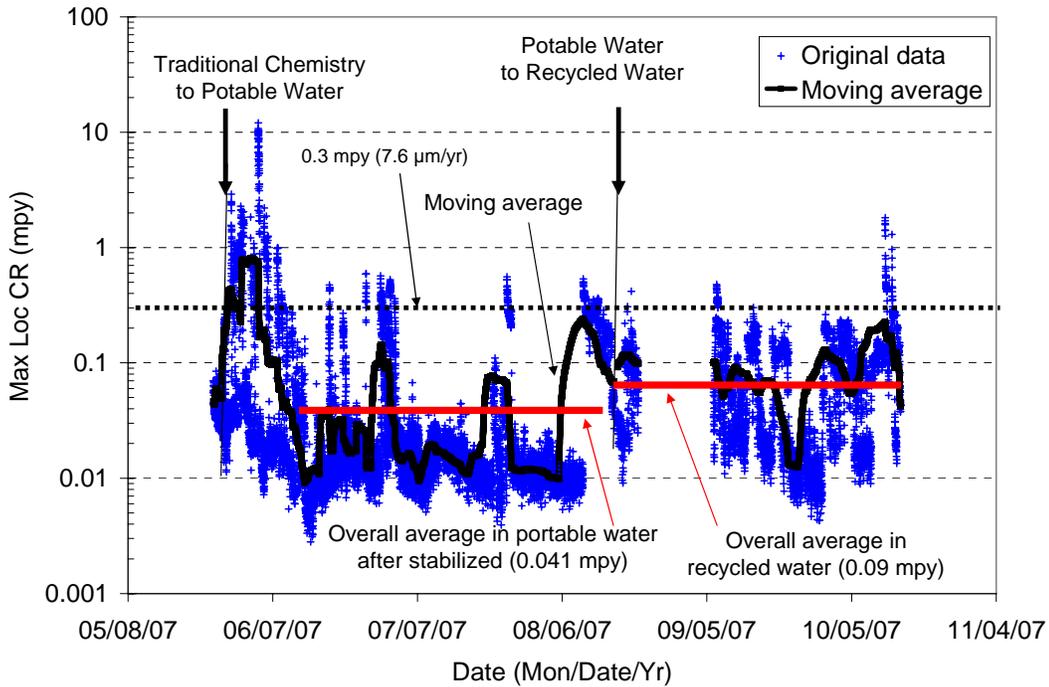
Figure 3. Maximum localized corrosion rate measured with the copper CMAS probe following the transition from traditional chemical treatment, starting with potable water in late May and later switched to recycled water beginning mid August.

Figure 3 shows the maximum localized corrosion rate measured by the copper probe after the transition of the chemistry was initiated. From August 21 to September 6, 2007, the CMAS analyzer was accidentally turned off and no data were available for this period.

It appears that the maximum localized corrosion rate signal was noisy and there were spikes especially during the first 20 days. Figure 4 shows one of the spikes that occurred on July 25th while the system was still using potable water; the signal was well defined and does not look like that it was due to the random noise effect. The maximum localized corrosion rate was 0.01 mpy (0.25 $\mu\text{m}/\text{yr}$) prior to the spike and suddenly increased to 0.5 mpy (12.7 $\mu\text{m}/\text{yr}$) within one data interval (15 minutes). Then, the maximum localized corrosion rate gradually decreased to 0.3 mpy (7.6 $\mu\text{m}/\text{yr}$) over a period of 23 hours. At the end of the 23-hour period, the maximum localized corrosion rate suddenly dropped to the lower detection limit of the instrument within one data interval.

Therefore, Figure 3 indicates that only low levels of pitting corrosion occurred during the first 20 days and was generally exceptionally low afterwards. The pitting corrosion observed after the first 20 days was mostly short-lived; they lasted only for a few hours or a few days. Soon after the detection of the pitting corrosion, the metal was passivated and the pitting corrosion stopped. The corrosion rates in the first 20 days and thereafter is consistent with the trend of the general corrosion rate data (see discussions below for Figure 5).

Figure 3 also shows the moving average of the maximum localized corrosion rate and the overall average maximum localized corrosion rate during operation with potable makeup water followed by the change to recycled makeup water. The moving average of the pitting corrosion rate was well below 0.3 mpy (7.6 $\mu\text{m}/\text{yr}$) except during the first 2-week period when the moving average localized corrosion rate reached 0.8 mpy (20.3 $\mu\text{m}/\text{yr}$). During the first 2-week period, the water chemistry was not stable, due to previously noted transition upsets and operation of tower water chemistry below the desired control ranges.

The change from potable water makeup to ammonia laden recycled water makeup in mid August appears to have increased the copper corrosion rate from approximately 0.041 mpy (1.0 $\mu\text{m}/\text{yr}$) in overall average to 0.09 mpy (2.3 $\mu\text{m}/\text{yr}$) in overall average (see Figure 3). This increase would be expected with the increased corrosive potential of recycled water use, due to ammonia content (see below for Tower Chemistry section). A good example of the increased corrosiveness of the recycled water is that the plant has already had to replace the brass tower makeup control valves (not protected) due to the effects of high ammonia in the makeup water. However, copper corrosion was inhibited well below traditional chemical treatment corrosion rates (low TDS tower water) in this tower system by the control chemistry with this high TDS treatment method. Therefore the silica plus azoles chemistry effectively inhibited localized corrosion of copper in the high dissolved solids chemistry and ammonia content of the cooling tower water.

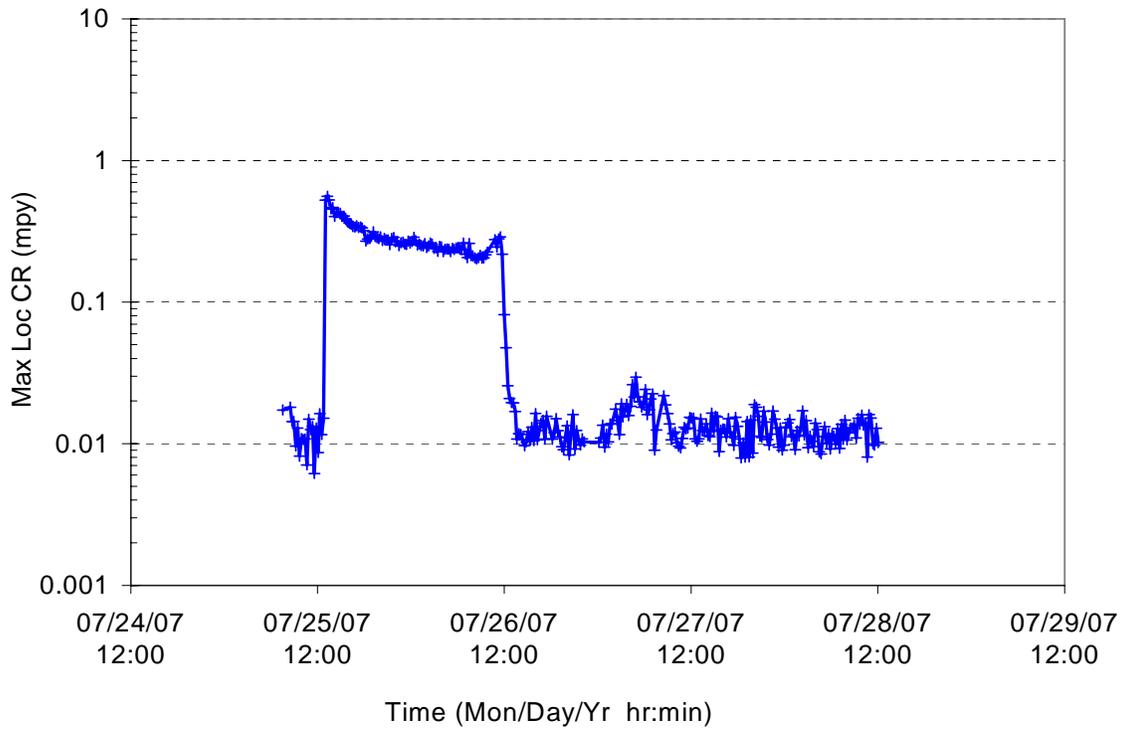
Figure 4. Low level of localized copper corrosion spikes during transition on potable makeup water.

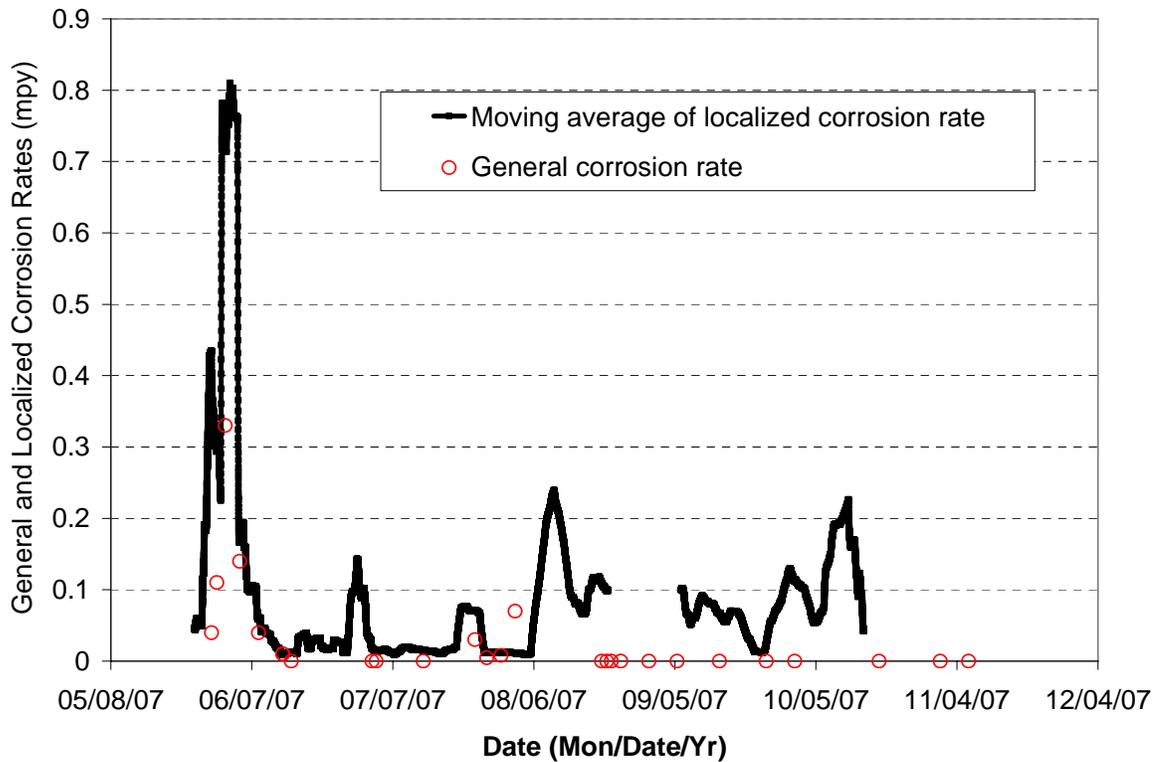
Figure 5. General copper corrosion rates obtained from a linear polarization resistance probe - Compared to low level of localized corrosion spikes and moving average of localized corrosion rate from the CMAS probe.

Figure 5 shows the general copper corrosion rate measured with the LPR method, along with the moving average of the localized corrosion rate for copper obtained with the CMAS probe. The general corrosion rate was high (from 0.04 to 0.33 mpy) in the first 20 days, and low thereafter (from 0 to 0.03 mpy except for one point of 0.07 mpy). In general, the trend of the general corrosion rate from the LPR probe agrees well with the localized corrosion rate from the CMAS probe. The LPR data were mostly zero when the localized corrosion rate from the CMAS probe averaged 0.05 mpy (1.25 $\mu\text{m}/\text{yr}$) during the study. Prior experience using LPR and weight loss methods to determine corrosion rates indicated that these methods were not effective or sensitive enough to detect changes in corrosion when using the ZBD (high TDS) and silica based technology, due to the extraordinarily low corrosion rates for steel, copper and other metals. Studies with special exposure techniques for weight loss coupons have confirmed that an elevated corrosion rate bias occurs due to under-mount coupon corrosion with the ASTM methods.^{5,6} Figure 5 demonstrates the small increase in copper corrosion was not detected with LPR in contrast to the shift in copper corrosion rate detected by CMAS data after implementing use of recycled water.

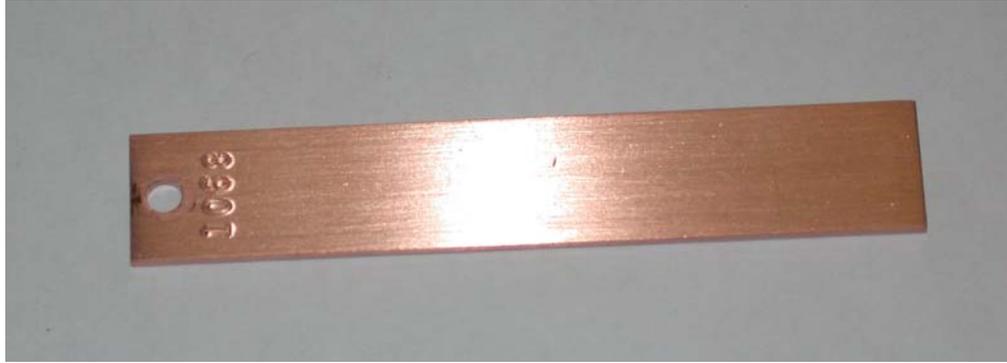
Figure 6. Copper coupon, exposed 99 days, for 0.16 mpy corrosion rate.

The copper corrosion coupon picture shown in Figure 6, confirms excellent corrosion control during the study. The corrosion rate was 0.16 mpy for 99 days exposure.

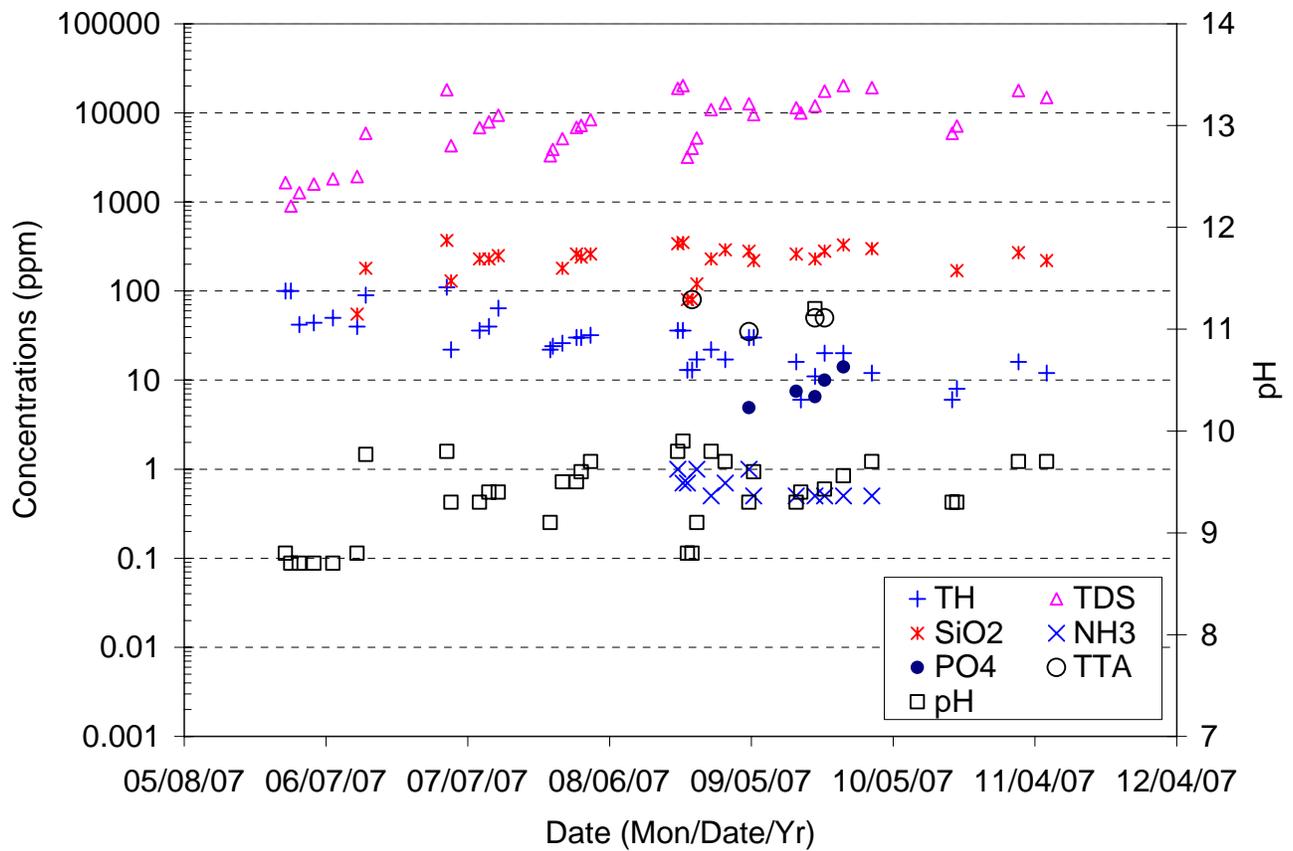
Figure 7. Chemistry of the tower water during the corrosion monitoring period (TH– total hardness).

Figure 7 shows comparative plots of the water chemistry from the tower. Shortly after the change from the traditional chemical treatment program to the silica inhibited water chemistry, three key parameters (pH, TDS and Silica) were below the desired treatment control ranges. It took about 2 weeks for those values to reach their steady state target ranges (above 9.5 for pH, greater than 10,000 ppm for TDS and greater than 300 ppm for Silica). The TTA residual was controlled between 20 and 60 ppm. The TTA residual was maintained via small slug dose every two to four weeks since there was minimal loss with zero tower blowdown. Total hardness decreased slowly from 100 to 10 ppm which limited how quickly desired tower water control concentrations could be achieved. The ammonia concentration naturally dropped to 0.5 to 1 ppm in the tower water after the change to recycled water

due to loss of ammonia gas over the tower with ammonium ion conversion to ammonia gas at tower elevated pH equilibrium. No apparent correlation can be drawn between the corrosion rate and other chemical parameters in these data except for the expected impact with change to tower water with ammonia content.
