ONLINE MONITORING OF UNDERCOATING CORROSIONS UTILIZING COUPLED MULTIELECTRODE SENSORS

Xiaodong Sun
Corr Instruments, LLC
San Antonio TX, USA

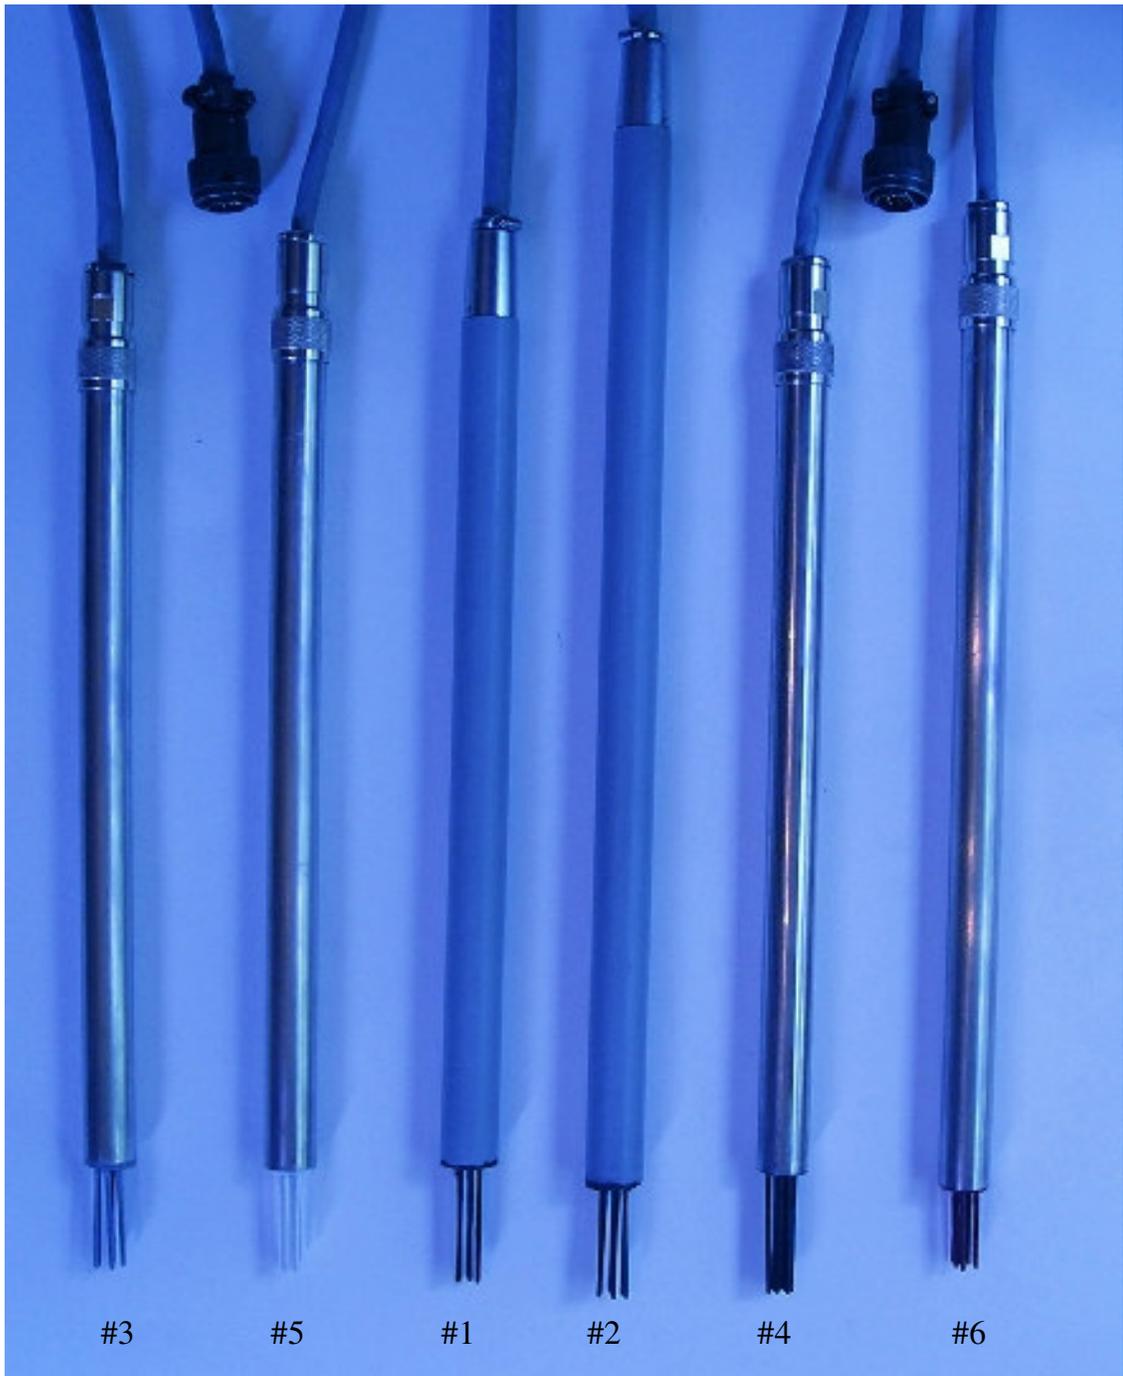
Figure 1. Coupled multielectrode sensors painted with different coatings for the experiment.

Figure 1 shows the 6 sensors used in the experiment. Their coating configurations are given in *Table 1*. Sensors #1, #2 and #6 were coated with the same type of epoxy. The tips of 3 electrodes (electrodes 1, 4, and 8) in sensor #1 and all electrodes in sensor #2 were mechanically scratched to simulate the initial defects (pinholes) on the coating. All sensors were immersed in a simulated seawater and tested at 26°C. The simulated seawater was prepared with 3% sea salt (Vigo Importing Co., Tampa, Florida, USA) and distilled water.

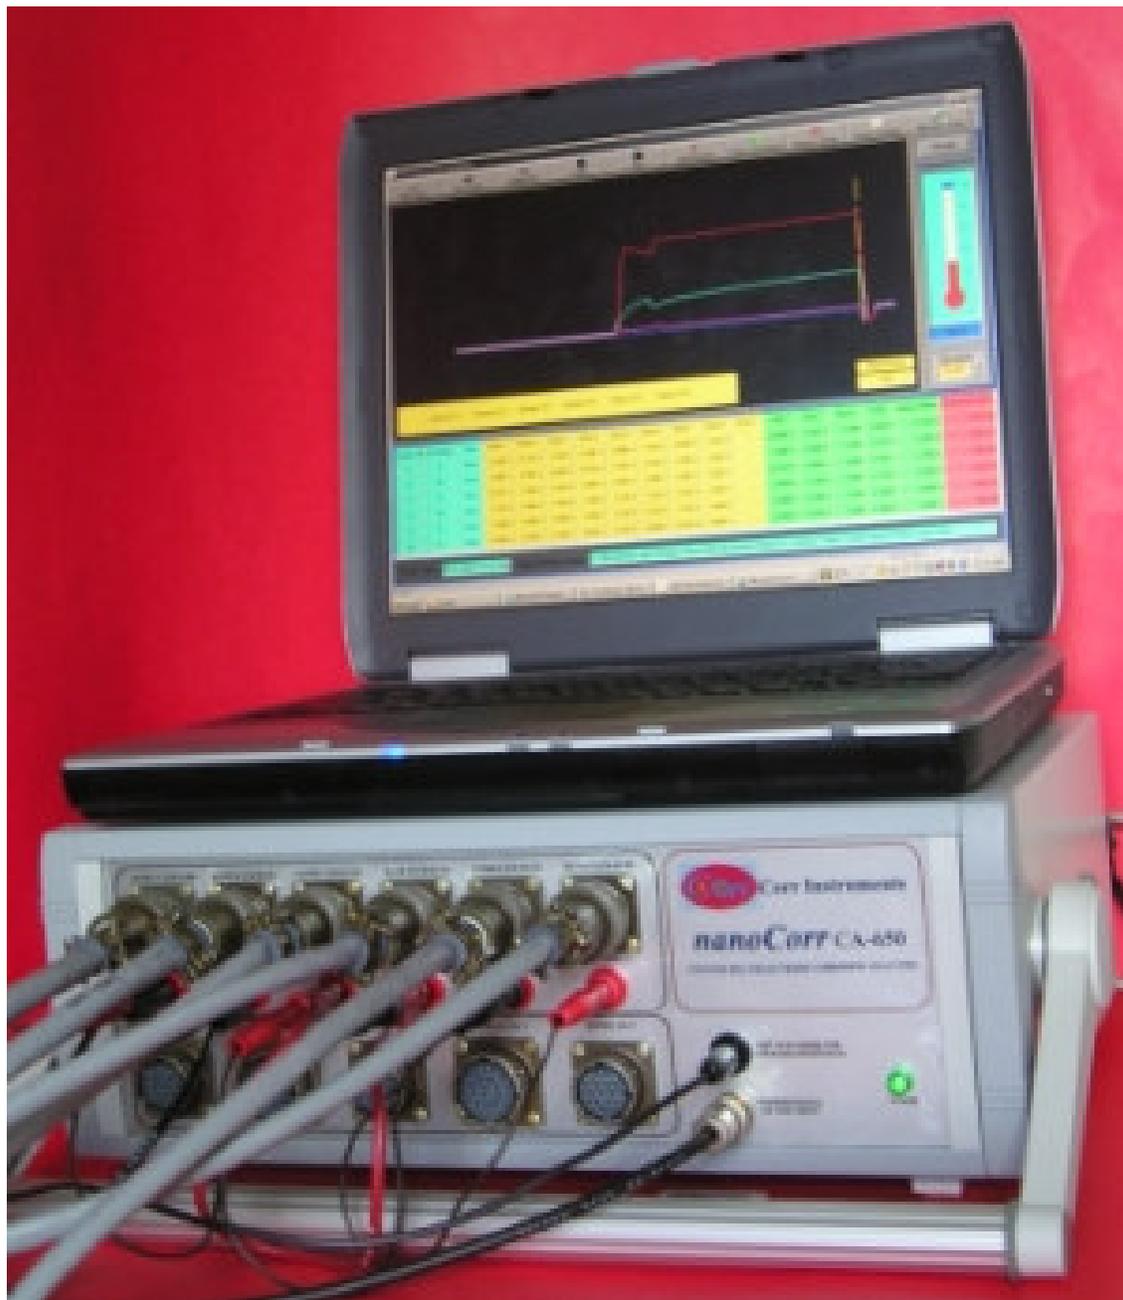
Figure 2. Experiment setup: Six sensors connected to the coupled multielectrode corrosion analyzer system.

A nanoCorr^{TM*}-50 Coupled Multielectrode Corrosion Analyzer⁶ manufactured by Corr Instruments (San Antonio, TX, USA), was used in the experiment. This coupled multielectrode analyzer has a high current resolution (10^{-12} A) and allows the measurement of coupling currents from up to 50 electrodes. *Figure 2* pictures the experimental setup during the measurement. Six sensors were connected to the coupled multielectrode corrosion analyzer and measured at the same time. The common coupling joint² of each sensor was connected to a large stainless steel (UNS S30400) cathode (surface area 30 cm²) so that each of the sensing electrodes would be an anode, when the coating on it failed. A notebook computer and the factory supplied software, CorrVisual^{TM*}, were used in conjunction with the multielectrode analyzer. The currents from each electrode of the sensors, the electrochemical potential of each sensor against a saturated calomel reference electrode (SCE), and the temperature were logged at a user-specified interval (usually 20 to 120 seconds) and saved in a computer file. Processed signals, such as the localized corrosion current and cumulative charge for each sensor, were saved in a separate file. Other processed signals, such as the corrosion rate and cumulative corrosion damage (penetration depth), would be also recorded in the processed data file, if the surface areas of the damaged coating on the sensing electrodes were known. During the measurements, all of the directly measured currents, the statistic values of the measured currents for each sensor (minimum, maximum, mean, and cumulative charge), the electrochemical potential of each sensor, the temperature, and other useful parameters for data acquisition were also displayed dynamically on the computer screen, in both numerical and graphical forms.

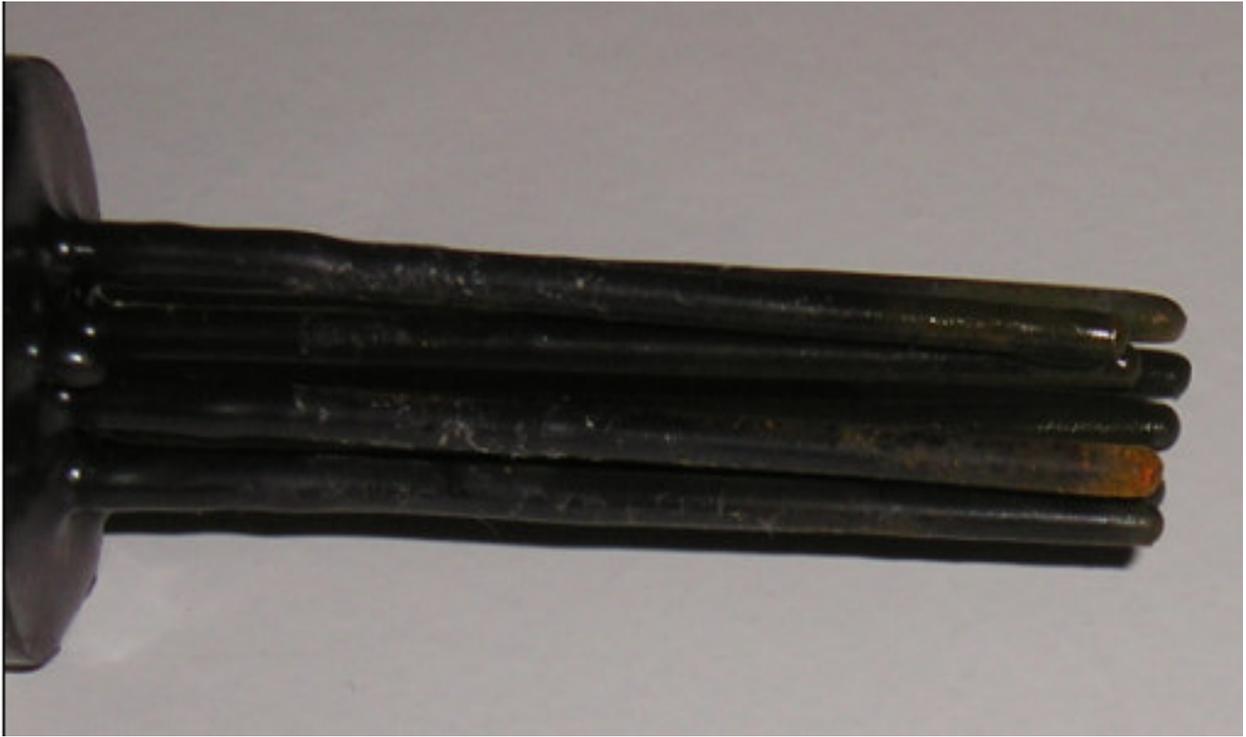
Figure 4. Appearance of sensor #1 electrodes, after a 7-day immersion in brine solution. Coatings at the tips of three electrodes had initial defects prior to the test. Rust developed on these three electrodes after the 7-day immersion. Only one of the three electrodes can be seen in front of this photograph.

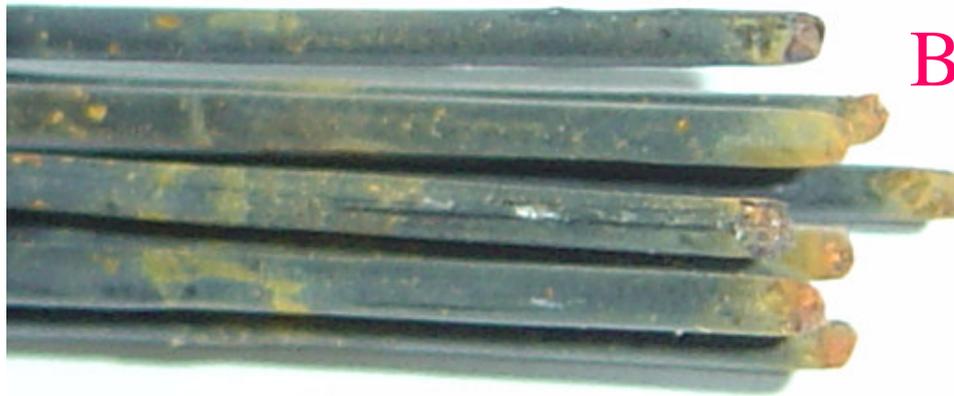
Figure 5. Appearances of sensor #2 electrodes, after 7 days (A) and 17 days (B) of immersion in a brine solution. Coatings at the tips of all electrodes contained initial defects prior to the test. The tips of the electrodes had rusted after 7 days and were severely corroded after 17 days of immersion.
